Assessment of the Crack Level in Silo Foundations Due to Settlement

One of the largest feed companies in Indonesia is PT X, which produces the largest feed and processed food in the country. The case study for this research is from the Expand SILO Structure of PT. X located on Jalan Raya Serang, Tangerang Regency. The Expand SILO structure serves as a place for livestock feed production, with the hope that it can last for a relatively long time. The condition of the existing SILO structure is currently some cracks in several parts of the piles and the bottom slab. Therefore, it is very important to conduct an analysis of the current condition and feasibility of the existing SILO structure in withstanding the working loads. This aims to assess its utility based on safety factors and maintenance. To assess the feasibility of the existing SILO structure, a visual inspection for check of the crack level due to settlement. It is expected to obtain the results of the feasibility information of the existing SILO structure through structural analysis so that it can provide recommendations for repairs/strengthening if necessary.

Structure Name : Silo Foundation PT. X (Code: 17,18,19,20,21

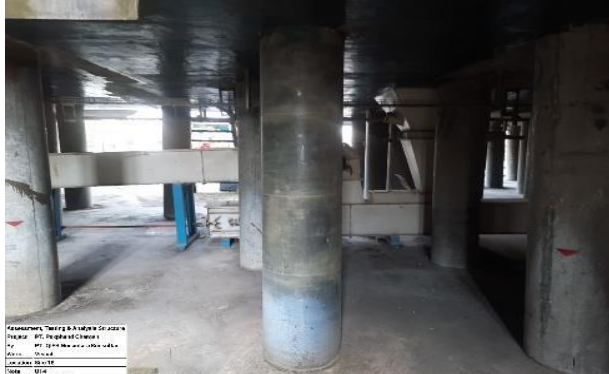
<p>Silo 18</p>	
  <p> <small> Revisi: 000 Tanggal: 02/09/2024 No. Dokumen: 000 No. Revisi: 000 Tanggal: 02/09/2024 </small> </p>	<div style="text-align: center; margin-bottom: 10px;">   </div> <ul style="list-style-type: none"> - The condition of the plate/slab structure has some cracking, but it has already been coated with carbon fiber FRP.
  <p> <small> Revisi: 000 Tanggal: 02/09/2024 No. Dokumen: 000 No. Revisi: 000 Tanggal: 02/09/2024 </small> </p>

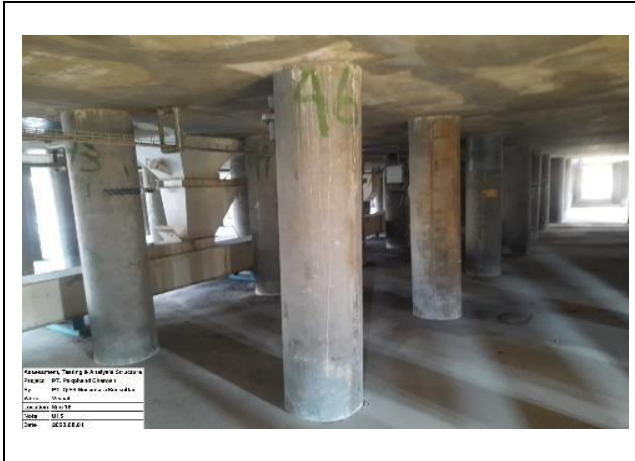
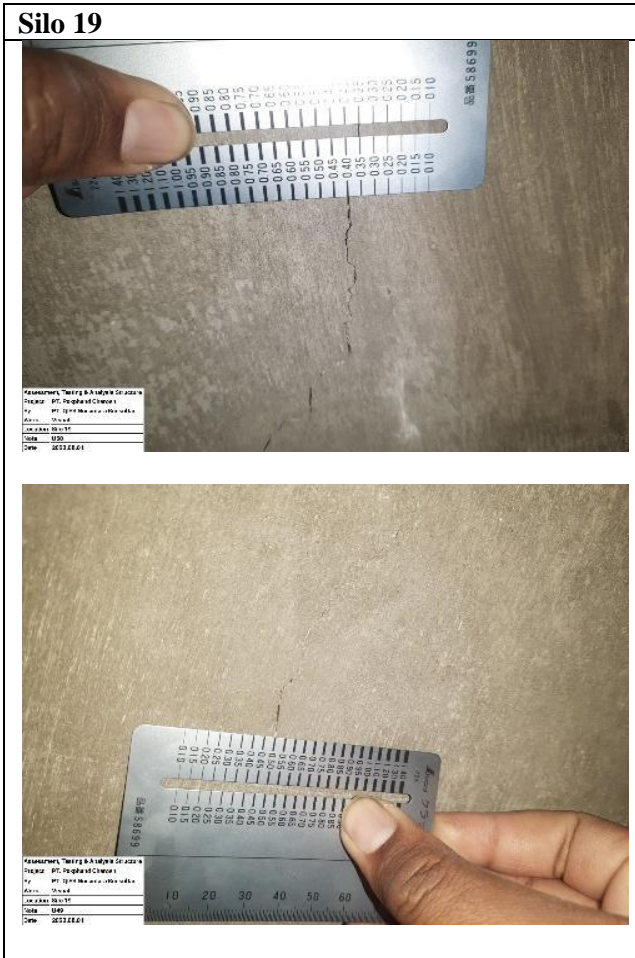
</div> <ul style="list-style-type: none"> - The spun pile condition has some cracks, but it has already been coated with FRP carbon fiber.
--	--

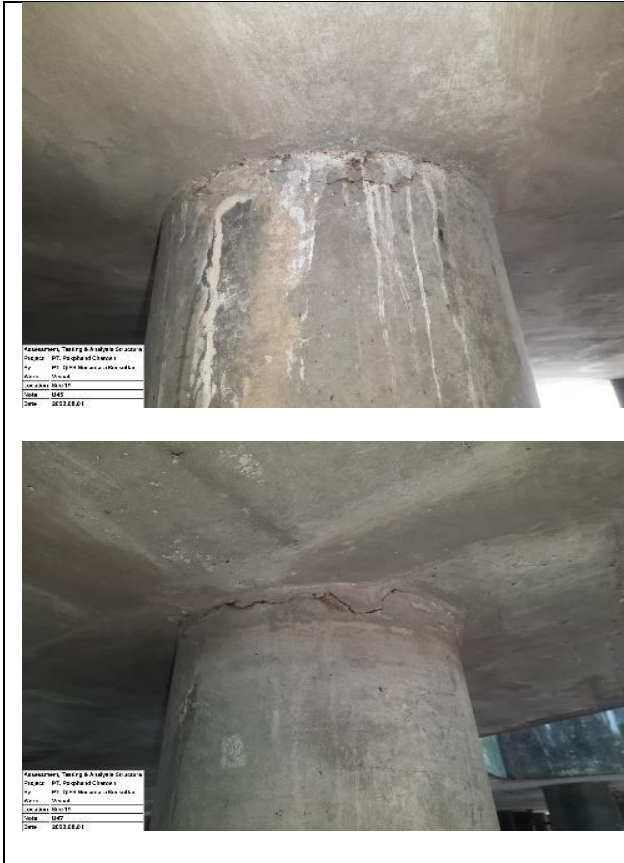
- The condition of the plate/slab structure has some cracks 0,4mm – 0,5mm.

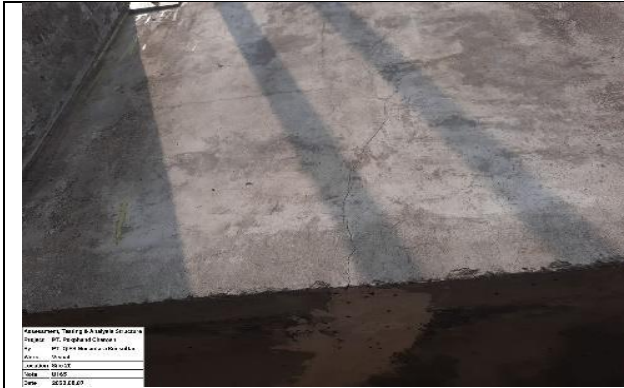
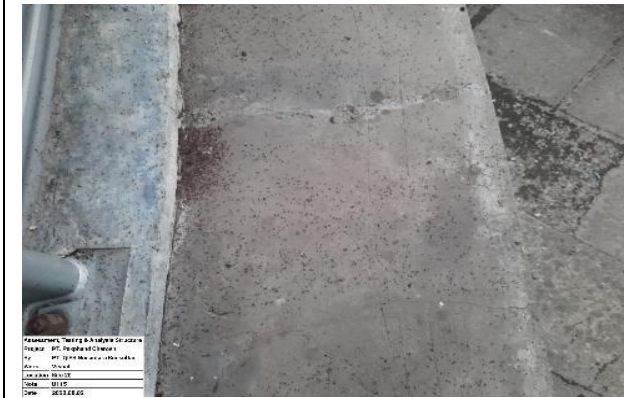
Silo 20

- The condition of the spun pile structure is still quite good.

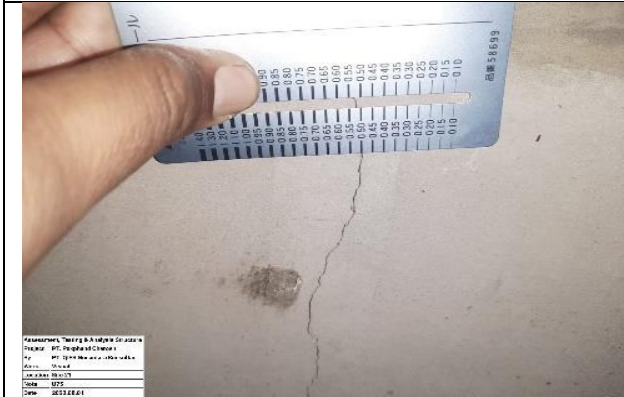
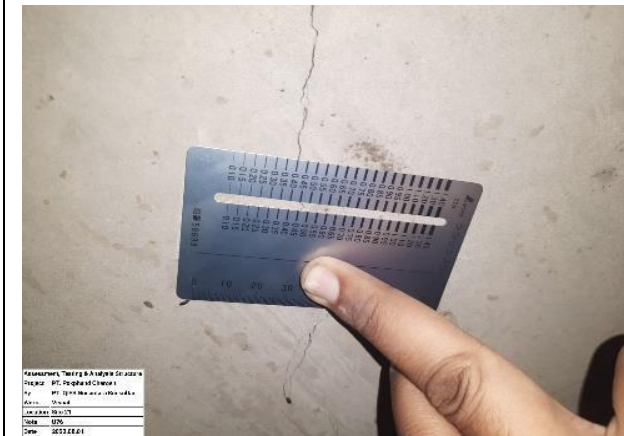
Silo 21

- The condition of the plate/slab structure has some cracks 0,3mm – 0,4mm.

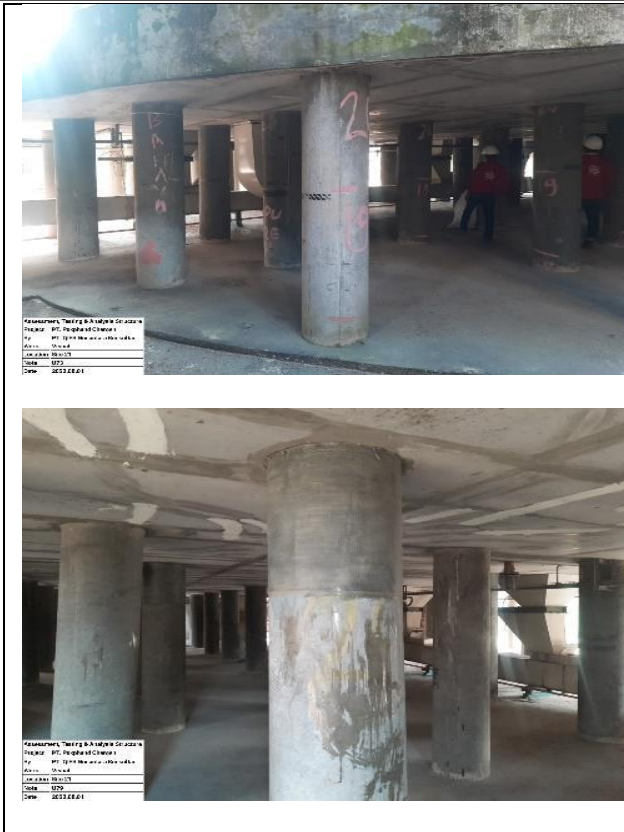
- The condition of the plate/slab structure has some cracks 0,4mm – 0,5mm.

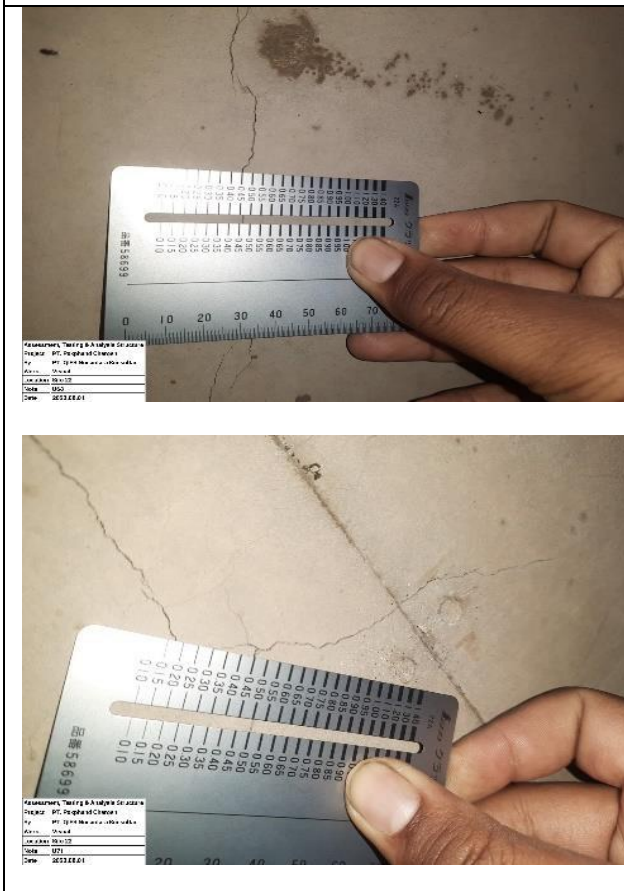
Silo 22

- The spun pile condition has some cracks, but it has already been coated with FRP carbon fiber.

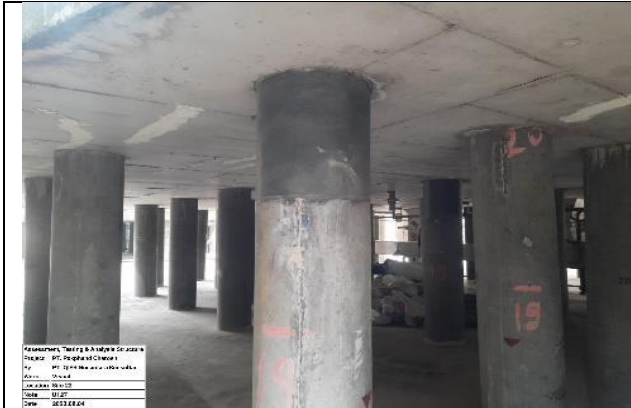
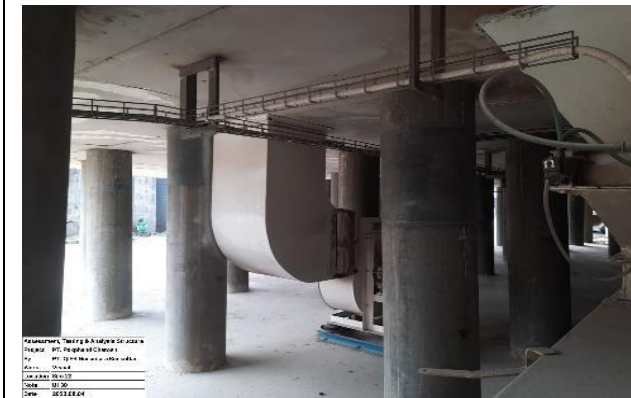
- The condition of the plate/slab structure has some cracks 0,35mm – 0,5mm.

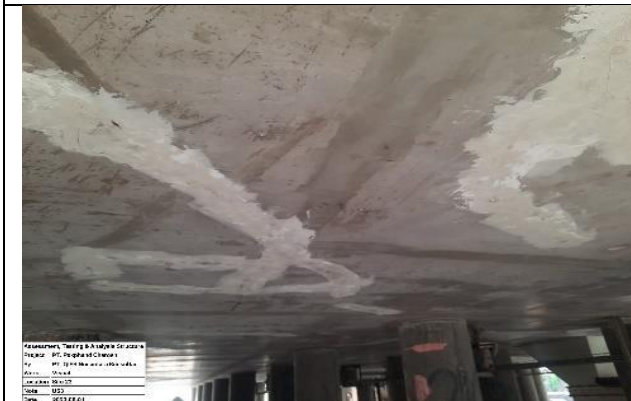
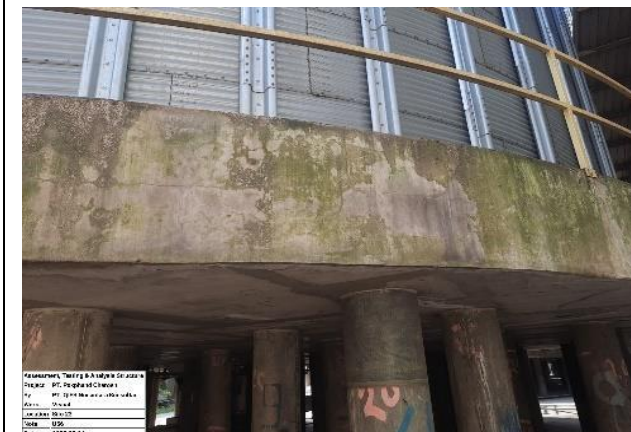
Silo 23

- The spun pile condition has some cracks, but it has already been coated with FRP carbon fiber.

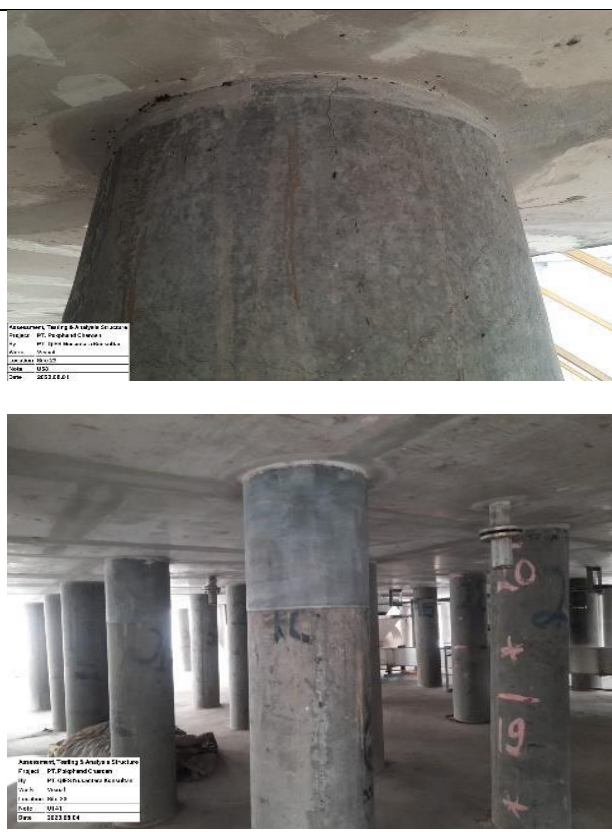
- The condition of the plate/slab structure has some cracks 0,35mm, but injection and patching have been carried out.
