## Testing of Concrete Structures with Non-Destructive Test Method (NDT) Using Ultrasonic Pulse Velocity (UPV) at the Building on the Ancol Beach

*The UPV test procedure with the PUNDIT device is set based on the concept of the wave flow speed passing through a solid object bound to the elastic properties of a tangible medium. When used properly and correctly, this tool will provide a lot of information about the condition of the surface or the inside of the concrete. Classification for pulse velocity results according to the speed criteria of concrete quality presented in BS 1881: Section 203:1986 as follows: 4500 m/s = excellent concrete condition, 3400 – 4500 m/s = good concrete conditions, 3000-3500 m/s = medium concrete situation, < 3000 m/s = concrete problem condition (doubtful concrete condition). The pulse velocity test results are measured by three methods: direct transmission, semi-direct transmission and indirect or surface transmission. The test results for the structure of the beams, cylinders, tie beams, and floor plates of the office building on the edge of the anchor showed that it is in medium concrete condition. The average value of the estimated quality of conc

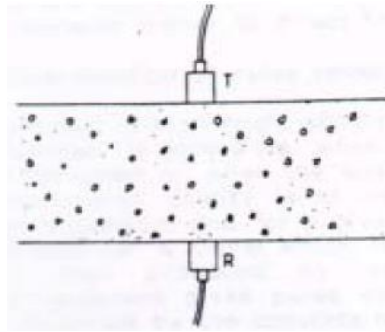
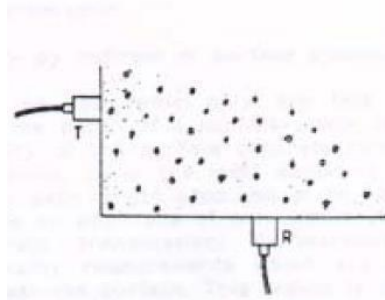
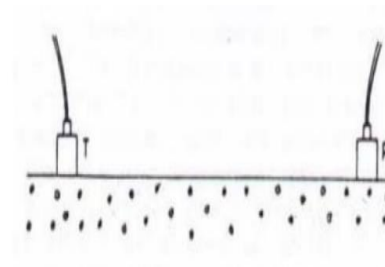
Figure 2. Methods of Pulse Velocity Measurement

UPV Pundit tests are conducted according to SNI ASTM C597:2012, BS 1881: Part 203:1986, and ASTM C597-16. This rule explains if the receiver's transducer is able to detect the arrival of early-arrival pulse components [4]. Three methods, among others, can do Pulse Velocity measurement:

a. Direct transmission

b. Semi-direct transmission

c. Indirect/surface transmission

This step is where the pulse velocity is measured with the instrument. After a brief explanation of the standard used, there are three ways to measure pulse. Direct transfer is highly recommended for recording because the results are the most accurate. Still, the limitations of field recording, the results obtained by semi-direct transfer can be said to be very real, and the latter is indirect/surface transfer, which is the method that uses the worst results compared to other methods but must be reduced so that the results approach the pulse values of the direct transmission frequency. Every time you do an inspection, you should apply an ultrasonic gel to the concrete that will be inspected.

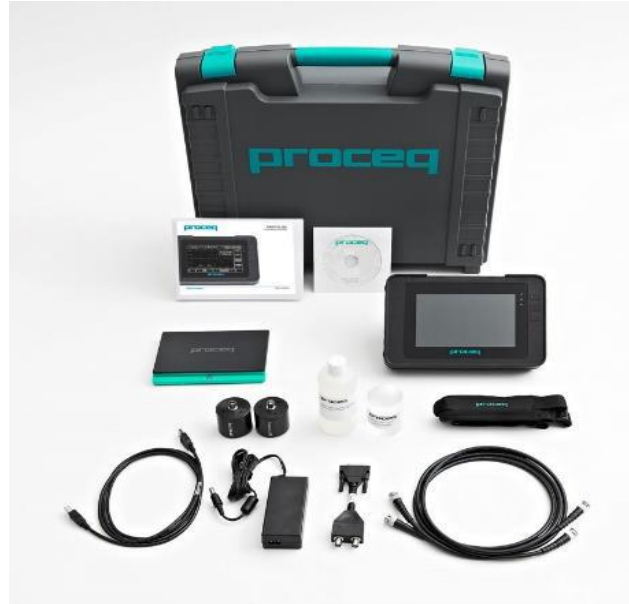
Figure 3. UPV PUNDIT Device

As for the UPV tool parts, the PUNDIT device consists of:

- a. UPV Pundit Lab Digital Version
- b. Stone Asah Gerinda
- c. Calibration instrument
- d. Ultrasonic Oil
- e. Mister or meter
- f. Wire brush
