## Construction of Clean Water Supply and Ablution Facilities at Al-Ikhlas Mosque

Muvi Yandra<sup>1\*</sup>, Totoh Andayono<sup>2</sup>, Yuwalitas Gusmareta<sup>3</sup>, Henny Yustisia<sup>4</sup>  
<sup>1-4</sup> Civil Engineering, Faculty of Engineering, Universitas Negeri Padang, Indonesia  
\*Corresponding Authoremail: [muviyandra@ft.unp.ac.id](mailto:muviyandra@ft.unp.ac.id)

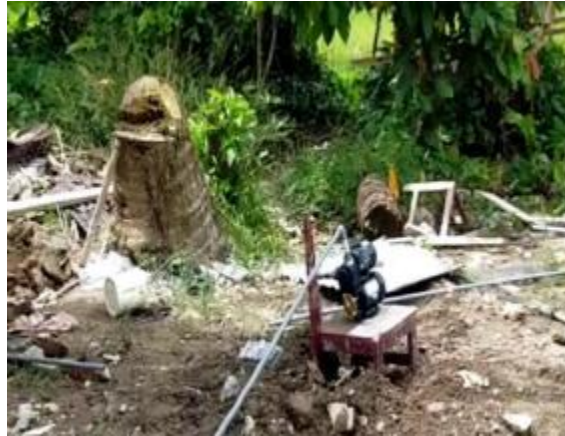
Figure 3: Installation and setup of the water pump.

The first construction component was the water-lifting and storage system. A pump was installed near the well to transfer water to the tank. A steel tower approximately 2.5 m high was constructed from  $50 \times 50 \times 5$  mm angle steel. The tower elevated the 500 L tank and

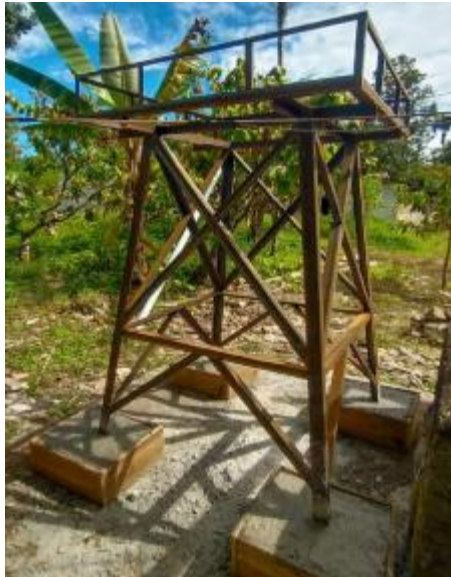
Figure 4: Construction of the water-tank tower.

allowed gravity flow to the ablution faucets. The arrangement reduced the need for congregants to draw water manually.

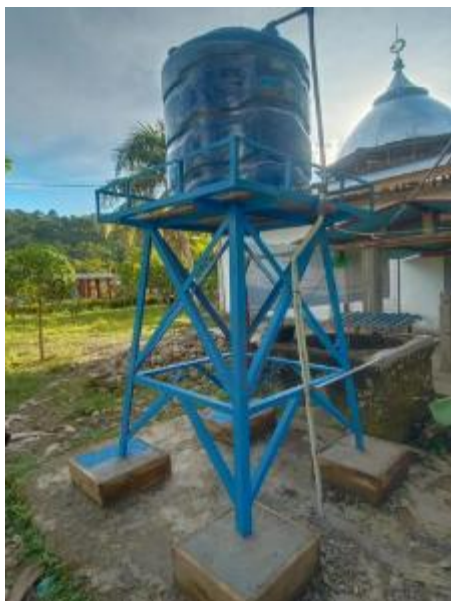
Figure 5: Painted tower, piping installation, and 500 L water tank.

The tank and piping system created a simple source-to-storage-to-user arrangement. For continued operation, the well area, pump, tank cover, tower, and pipe network should be inspected routinely. WHO guidance for small supplies recommends preventive risk management and sanitary inspection to identify contamination pathways and maintenance needs [3], [4].

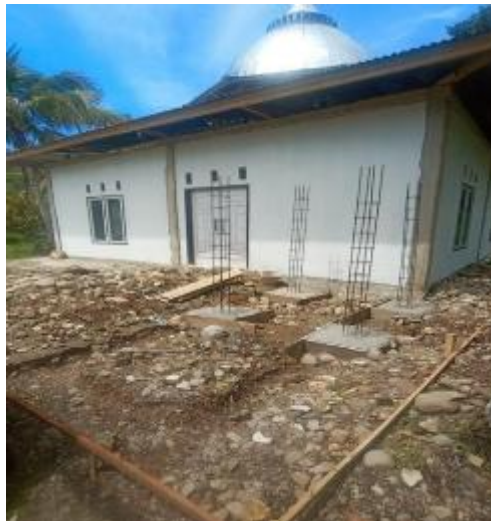
Figure 6: Assembly and casting of reinforced columns.

The ablution facility was constructed beside the mosque. The work included clearing the site, installing bowplanks, constructing foundations and reinforced columns, building concrete-block walls, casting the floor, installing the roof, and connecting PVC pipes and faucets. The final facility provided sheltered access to water for ablution.

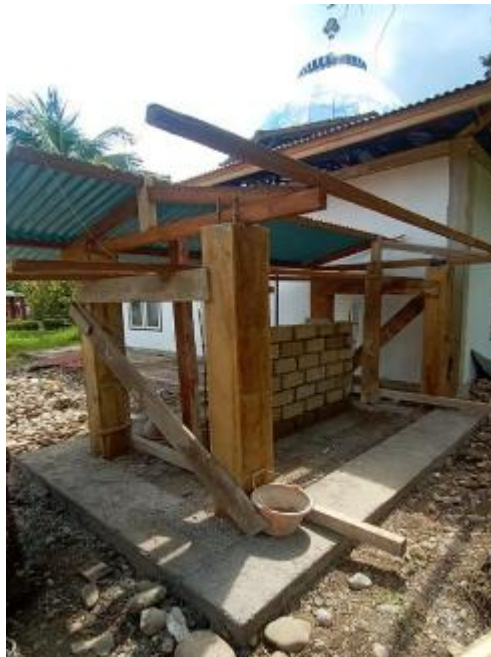
Figure 7: Floor and column work, concrete-block walls, and roof installation.

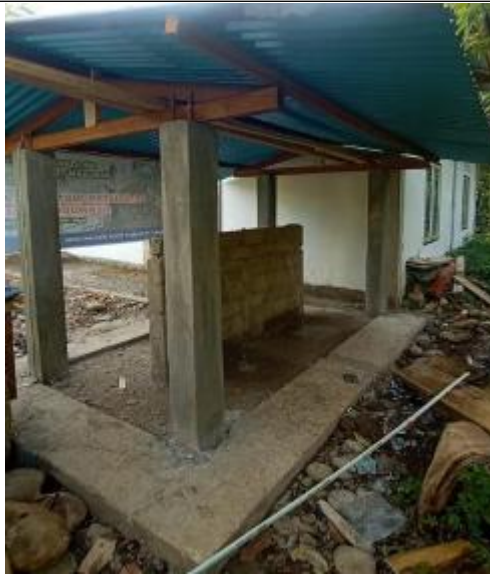
Figure 8: Completed structural form of the ablution facility.

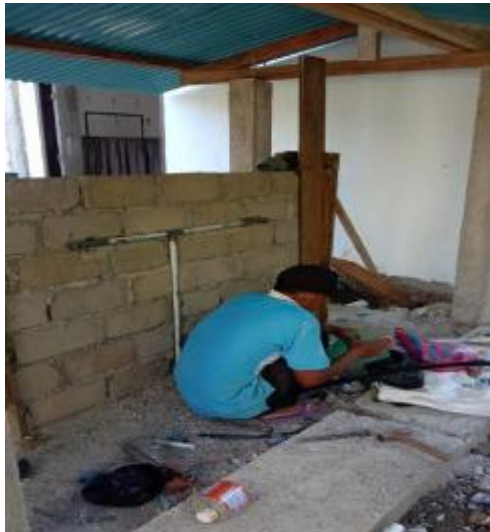
Figure 9: Installation of PVC pipes at the ablution facility.

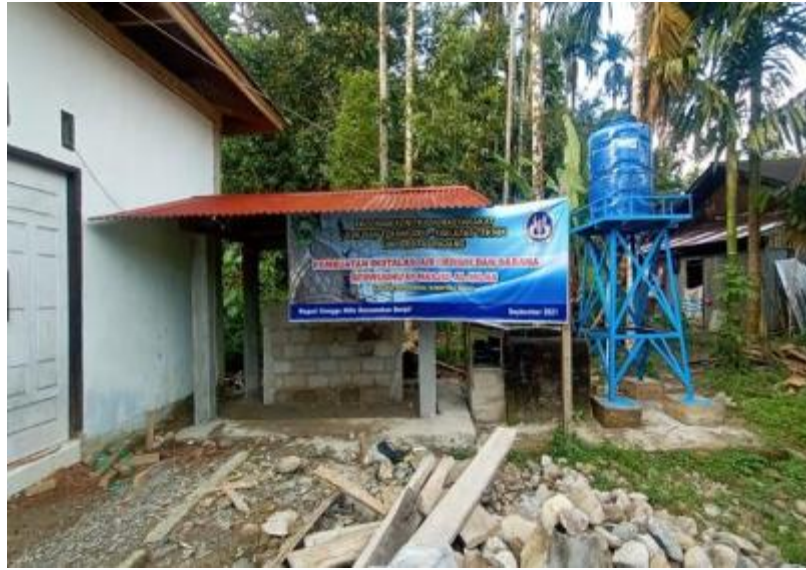
Figure 10: Completed clean-water and ablution facilities at Al-Ikhlas Mosque.

The community partnership activity produced a functional water-supply and ablution system at Al-Ikhlas Mosque in Sawah Nangguang. The completed components consisted of a water pump, a 2.5 m steel tower, a 500 L storage tank, PVC distribution pipes, a roofed ablution structure, and water faucets. The system transferred water from the well to the tank and distributed it by gravity to the ablution points, reducing the need for manual water lifting. Community coordination and student participation supported implementation. Continued benefits depend on routine inspection, tank and pipe maintenance, water-quality testing, and clear management responsibilities. Future improvement should include sanitary inspection and water-conservation measures.
