Assessment of the Crack Level in Silo Foundations Due to Settlement

One of the largest feed companies in Indonesia is PT X, which produces the largest feed and processed food in the country. The case study for this research is from the Expand SILO Structure of PT. X located on Jalan Raya Serang, Tangerang Regency. The Expand SILO structure serves as a place for livestock feed production, with the hope that it can last for a relatively long time. The condition of the existing SILO structure is currently some cracks in several parts of the piles and the bottom slab. Therefore, it is very important to conduct an analysis of the current condition and feasibility of the existing SILO structure in withstanding the working loads. This aims to assess its utility based on safety factors and maintenance. To assess the feasibility of the existing SILO structure, a visual inspection for check of the crack level due to settlement. It is expected to obtain the results of the feasibility information of the existing SILO structure through structural analysis so that it can provide recommendations for repairs/strengthening if necessary.

Structure Name : Silo Foundation PT. X (Code: 17,18,19,20,21

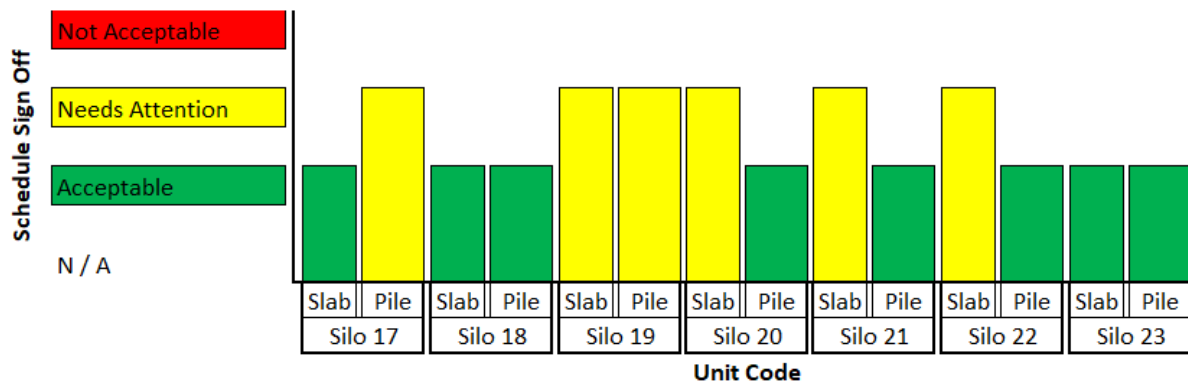
Figure 3. Graph of slab and pile silo's condition

The results of silo foundation condition after inspection and visual check the field based on images the matrix table above revealed several cracks in the spun pile foundation columns, with cracks in the foundation slab ranging from 0.3mm to 0.5mm. However, some of the cracks in both the foundation structure and the foundation slab have already been repaired through injection and coating with carbon fibre FRP. Subsequently, a recapitulation of the silo foundation structure conditions has been presented in the graph below:
